Runway Overrun During Rejected Takeoff  
Ameristar Air Cargo, Inc.,  
dba Ameristar Charters, flight 9363  
Boeing MD-83, N786TW  
Ypsilanti, Michigan  
March 8, 2017

NTSB/AAR-19/01  
PB2019-100293

# Aircraft Accident Report

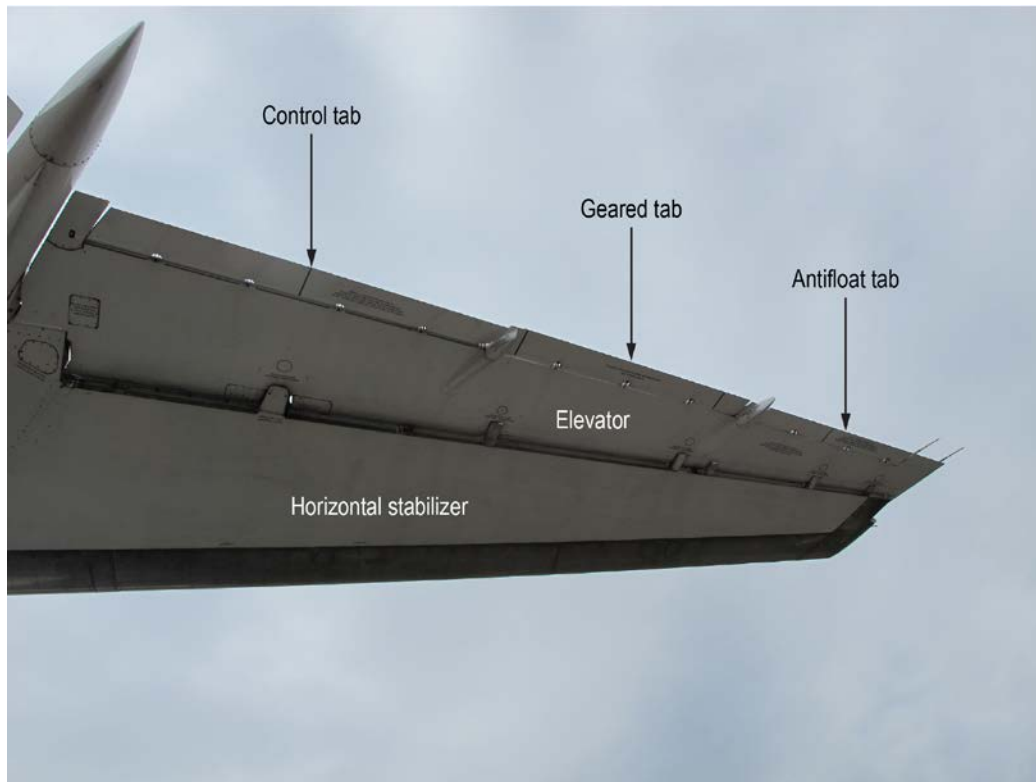
**Figure 3.** Right elevator and relative locations of control, geared, and antifloat tabs.

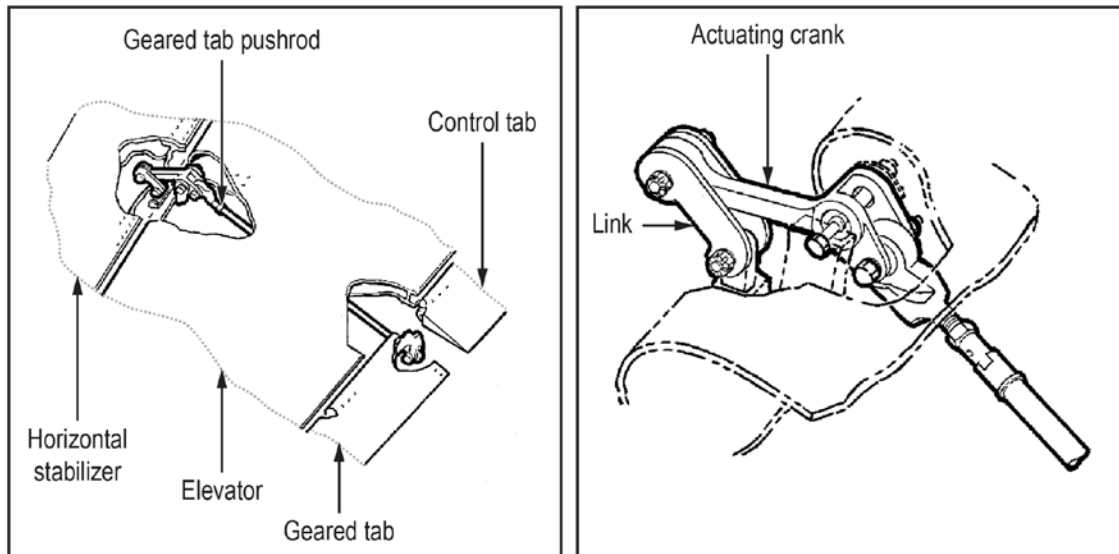
**Figure 5.** Drawing of installed location of geared tab linkage components (left) and closer view of the links and actuating crank (right).

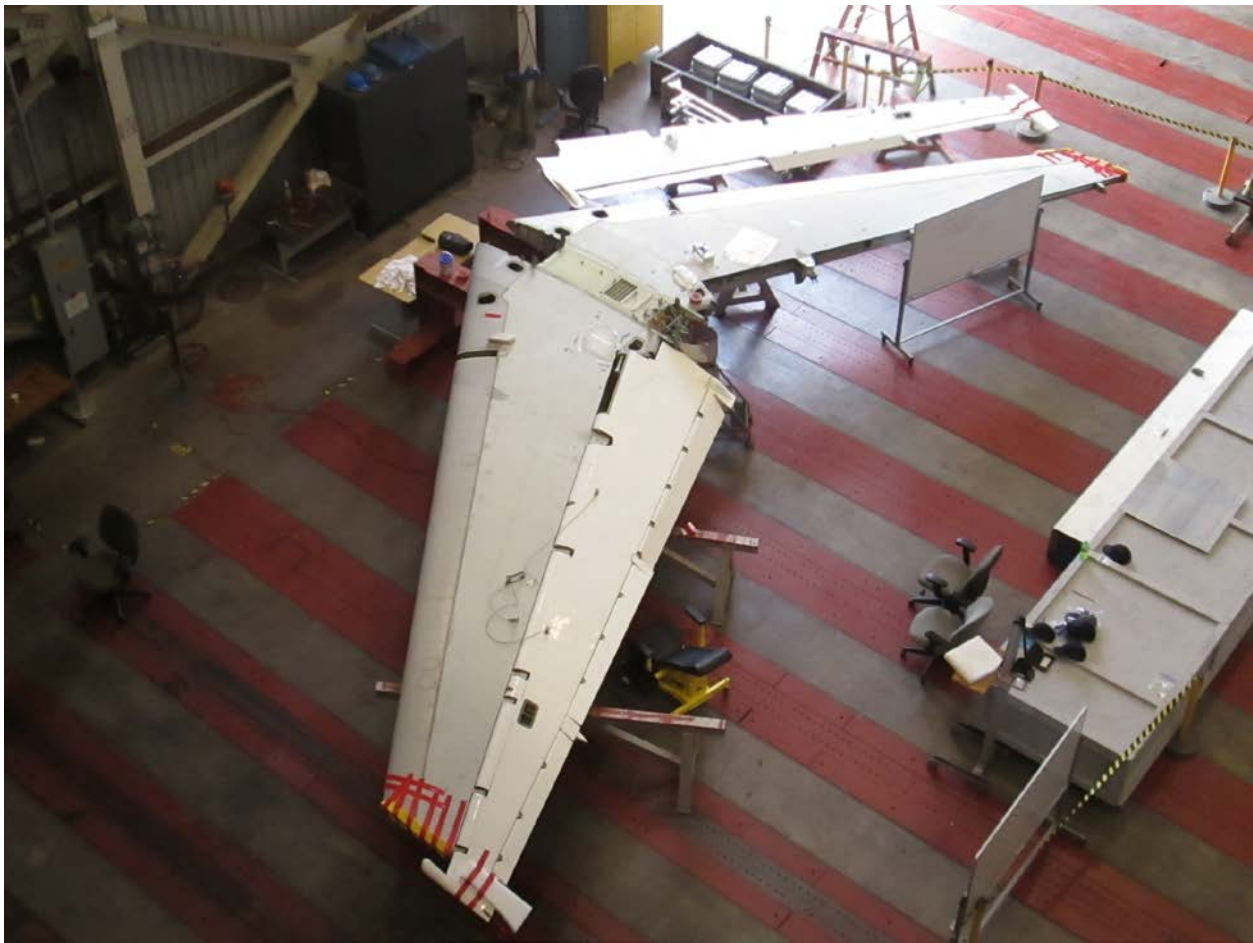
Considering the CFD wind simulation results and the overcenter position of the right elevator's geared tab components, the NTSB designed several series of static and dynamic elevator load tests to determine how an exemplar elevator system would perform under various gust loads. The tests were performed at the Boeing laboratory in Huntington Beach, California, using a test rig, which included a ground-based fixture supporting an exemplar horizontal stabilizer. Components from the accident airplane served as an exemplar elevator system and included the left elevator (with its torsion bar and stop arm assembly), right elevator damper, and right boost cylinder.<sup>26</sup> (Accident airplane components were examined and/or tested as described in section 1.10.2 before being used on the test rig.) A hydraulic test bench supplied pressure to the boost cylinder, representative of the airplane's hydraulic system (see figure 14).

**Figure 14.** Test rig representing an exemplar horizontal stabilizer and elevator system.

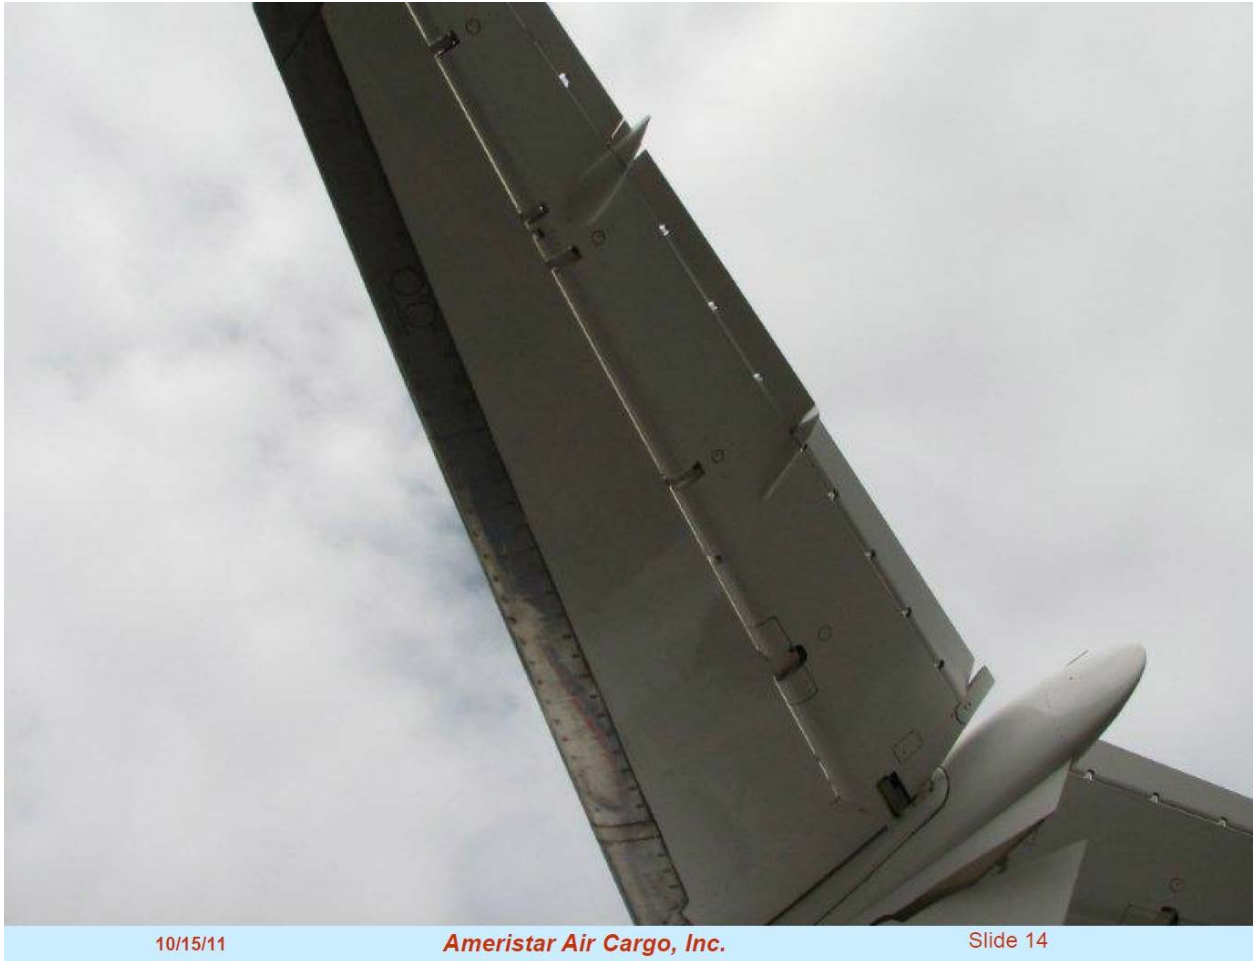
Ameristar was approved to use an "Advanced Pictorial Preflight" for the preflight training and proficiency checks per OpSpec A005, exemption 4416Q.<sup>32</sup> The pictorial, which consisted of a slide presentation, included a slide with a photograph showing a view from the ground of primarily one elevator and its tabs (see figure 16). A tabular description of the presentation referenced the proficiency check requirements and described the slide as showing the "elevators and tabs" as the "item to be checked" and indicated that the photograph depicted "condition good."

**Figure 16.** Excerpt from Ameristar’s preflight inspection pictorial training (elevator control system).
